Reduce the pressure

Managing pressure in shower commode chairs, particularly in the case of spinal injury patients

This whitepaper describes Wealden Rehab's view of the challenges faced by spinal injury patients using shower commode chairs particularly in relation to managing pressure and how patients can benefit from a shower commode chair that has been specifically designed for postural support and pressure relief.

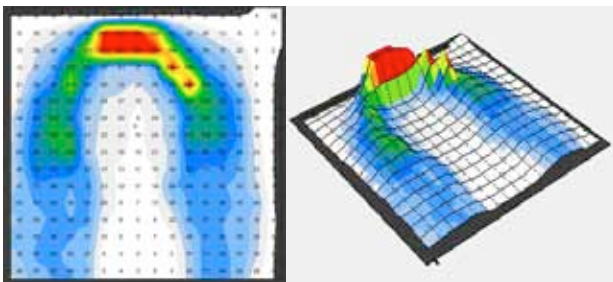
The patient transferred onto the Prism chair first and we recorded these pressures with the first seat, the medium horseshoe module:

This demonstrates the core issue: that peak pressure area at the sacrum exceeds even the higher limit of our recording device at 300+ mmHg.

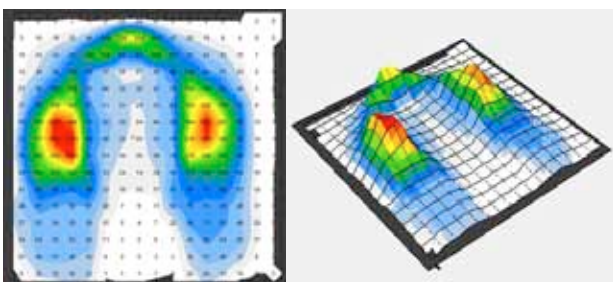
The chair was then fitted with the large horseshoe module to evaluate the differences between the seats.

This shows a big relocation of pressure across the seat surface, but the peak pressure areas are still reading at 300+ mmHg. The max pressure areas are now at the IT's however the pressure is very peaky, and still gives readings of over 200mmHg at the sacrum.

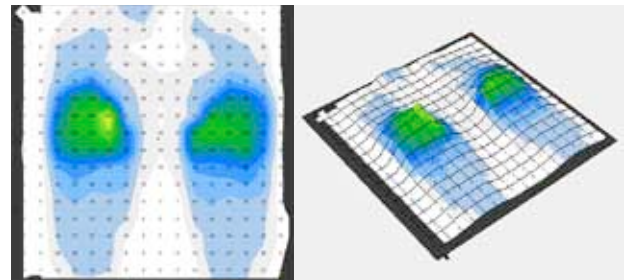
The mapping showed the following pressures:

This shows a max pressure of 204.53mmHg, and the pressure peaking over the ITs, with very little loading at the sacrum. This seat shows a dramatic reduction in the peak pressure on the seat.

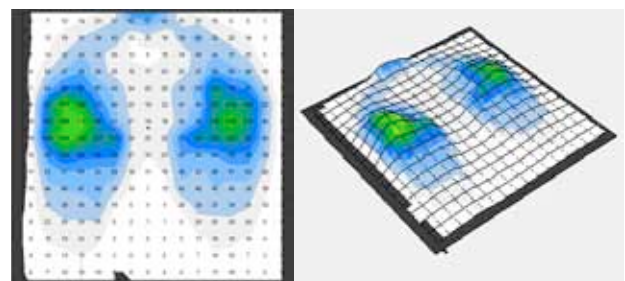
The seat module was then exchanged for the 19" visco foam seat and the patient transferred onto the chair.

With this seat we see a max pressure of 173.71mmHg. peaking over the ITs, whilst there is a touch more contact at the sacrum. This is probably down to the fact that the visco style provides more envelopment of the pelvis and more of the patients pelvis would be in contact with the seat top.

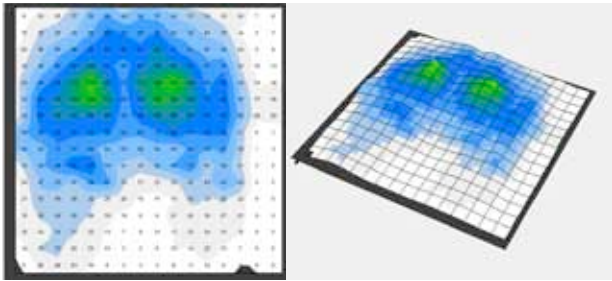
This is the result, with the patient sitting midline and relaxed, a maximum of 160mmHg and pretty even distribution as expected.

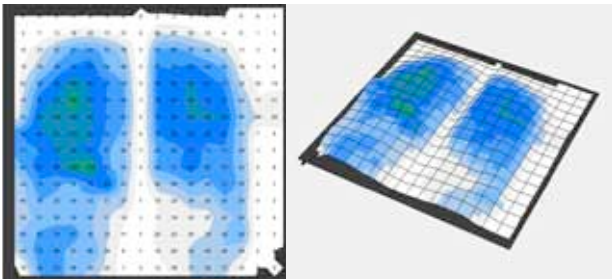
The pressure map recorded the patient performing weight shifts, both forward...

...proving the huge value of the weight shifts in releasing pressure on the seat tissues. Max interface pressures of 118mmHg in a forward lean, and just 93.5mmHg in a sideways leans.

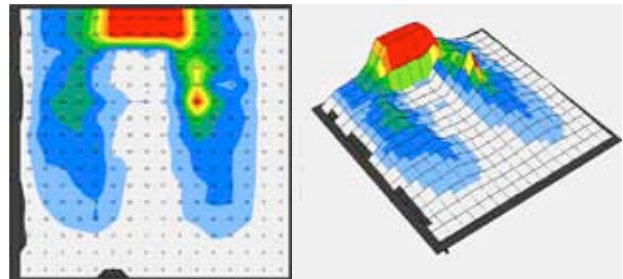
The interesting observation was the peak pressures recorded as the patient went through the initial transfer to the chair. The image looked like this:

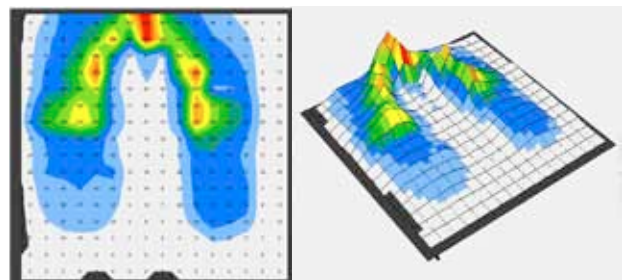
Whilst the patient felt no particular discomfort, he did comment on feeling less stable than he would aim for. The pelvis was clearly too far back over the aperture so we recommended a shift in position. By bringing the pelvis forward on the seat, the pressures appeared more even and lowered as far as they could, however the scan still shows in excess of 300mmHg at the sacrum, and ± 270 mmHg at the ischial tuberosities.

Unfortunately this meant that the patient was forced into sitting with a posterior rotated pelvis which brought with it complications. The position for voiding the bowel was awkward and likely impossible (we didn't try). The sacrum was clearly in contact with the seat top in preference to the immediate surrounding area. The seat was correspondingly too short leading to adduction of the knees. (This single issue could have been solved by 'prescribing' a longer seat module and lowering the footplates slightly.)

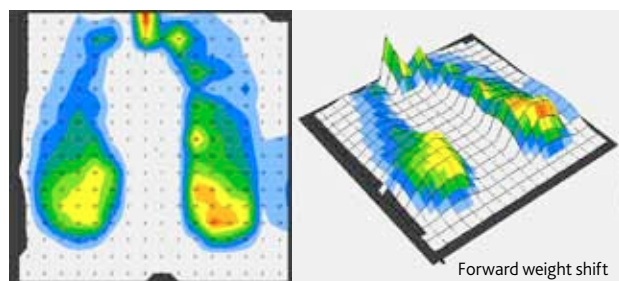
Having seen the benefit of weight shift earlier with the wheelchair cushion, we decided that we should record the effect of this on this seat.

Whilst this reduced the average pressure across the surface from 54.85mmHg to 24mmHg, there was still visible peaks around the sacrum. The patient gave feedback that he wasn't able to perform this weight shift effectively as the pelvis was in such rotation initially.

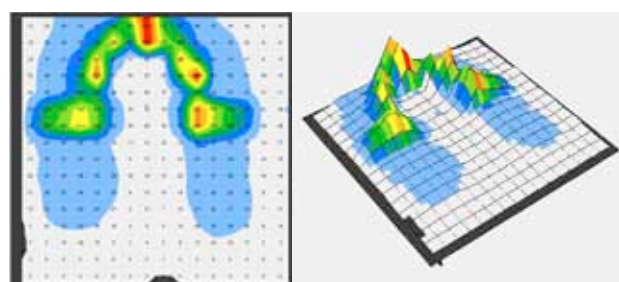
The first stop was at 17 degrees, with the patient sat with his elbows resting on the armtops.

In this midway position, the average pressure had started to reduce (now 44.31mmHg) but there was still points at the sacrum and rearwards of the IT's which identified with over 300mmHg.

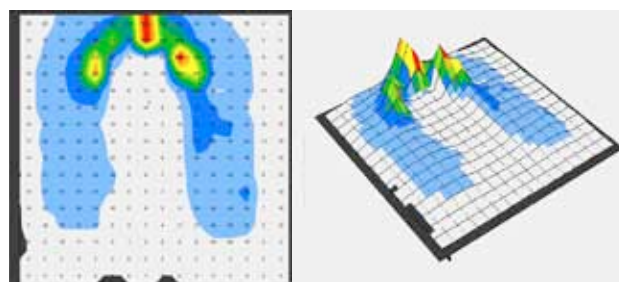
Moving into full tilt at 25 degrees, the average pressure is again reduced this time to 34.8mmHg, but the sacrum is still under significant pressure with peak readings of 300+mmHg.

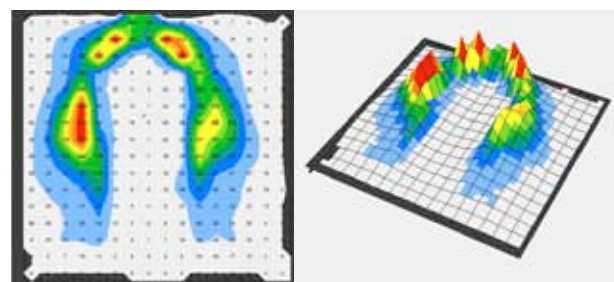
The chair proved a little difficult to transfer into as the soft seat top tended to move a little with any scrub as the patient moved across. Once the patient was seated and relaxed the first scan was taken.

With the footplates adjusted, the seat provided a good spread of pressure, however the peak pressure was recorded at 300mmHg both at the rear of the pelvis and around the sides of the commode aperture.

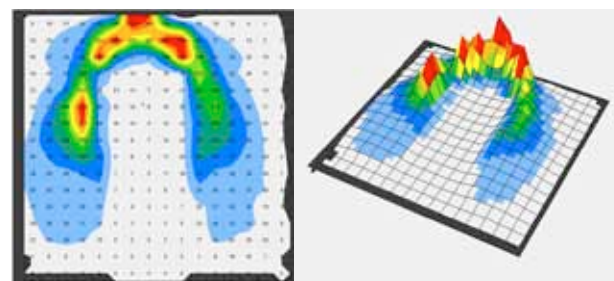
Tilting the chair demonstrated that pressure could be reduced overall across the seat with measurements taken at 20 degrees (maximum still showing at 300mmHg, but average pressure reducing to 45.4mmHg)...

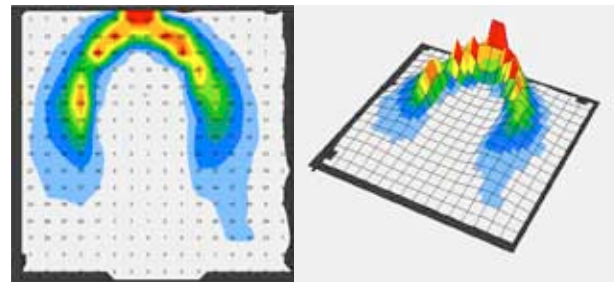
...whilst moving through to full tilt at 40 degrees shows a reduction in average pressure to 40.85mmHg. However the tilt has introduced a pressure buildup at the coccyx with large areas of tissue being subjected to pressures of over 300mmHg.

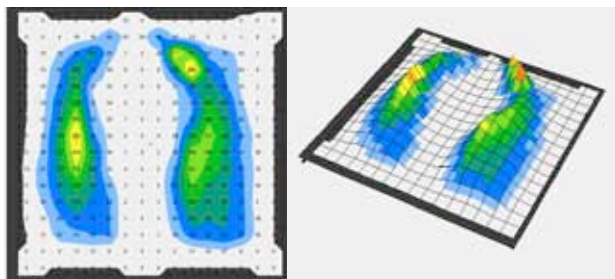
In the flat seat position, we recorded the action of performing a weight shift by leaning forward. This demonstrated that all the pressure could be relieved from the coccyx and that good distribution could be achieved under the femurs.

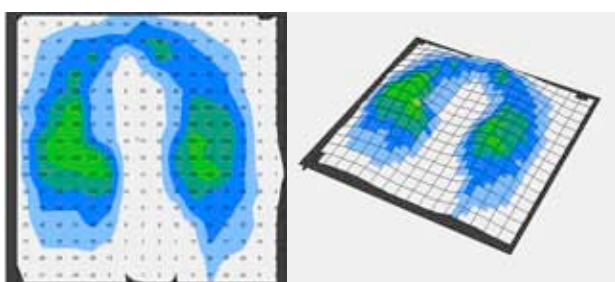
The first study we carried out was to look at the effect of a correctly adjusted arm height on the seated pressure. The first scan was the client sat with the seat adjusted to suit his pelvic position. In this first instance however his arms were resting on his thighs.

In this position the max pressure is reading at 154.43mmHg, and the average at 46.54mmHg.

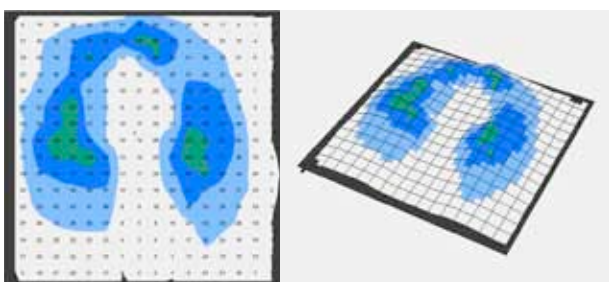
With the chairs arms adjusted to the correct height and the patients arms resting comfortably, the scan shows a reduction of max pressure to 120.89mmHg and average pressure to 35.81mmHg. This proves simply the value of supporting the arms at the correct height – by ensuring that our patient is using the arms we can reduce the interface pressures considerably (21.7% max pressure/23% average pressure reduction in this case).

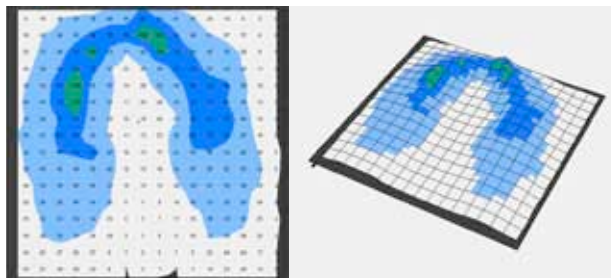
At 15 degrees, the max pressure was 121.5mmHg and average 33.75mmHg.

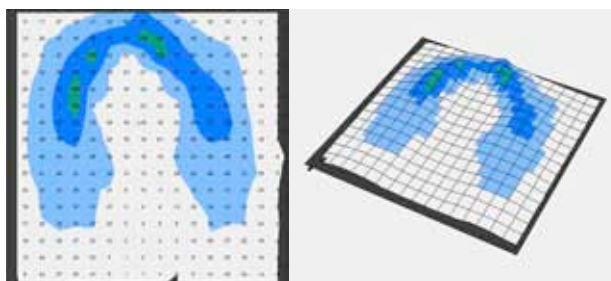
At 25 degrees the maximum pressure has fallen to 109.68mmHg and average to 30.68mmHg.

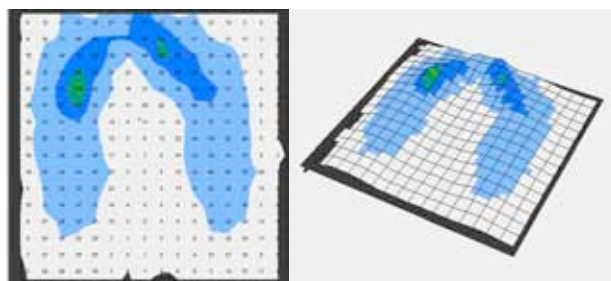
...and at 41 degrees the max pressure is 133.86mmHg with the average falling to 28.21mmHg.

The interface pressure exerted whilst using this chair seems considerably less than that of the other chairs trialled using the same patient.
